**BOG BROOK DAM**

**NH 00194**

**PHASE I INSPECTION REPORT  
NATIONAL DAM INSPECTION PROGRAM**

**JULY 1980**

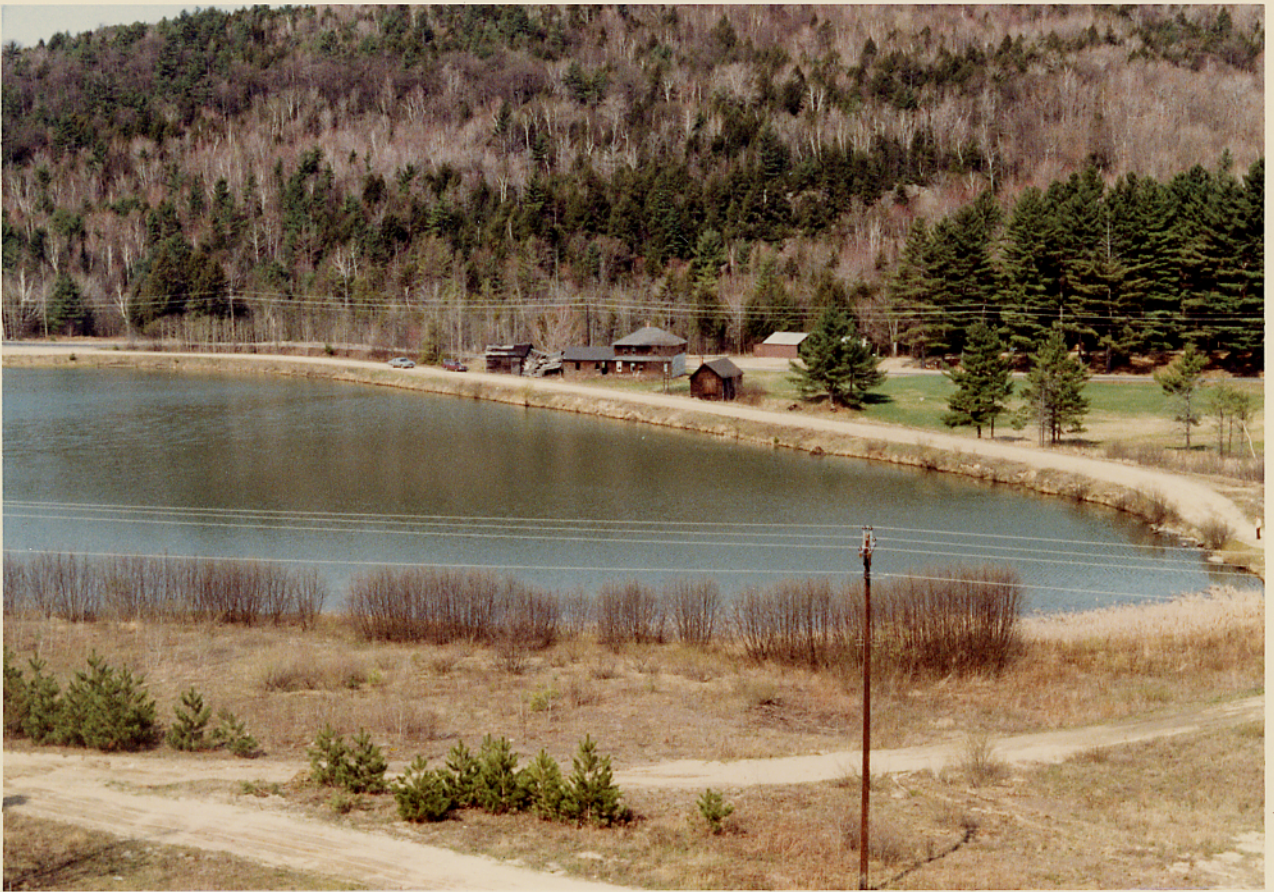
Overview of Dam

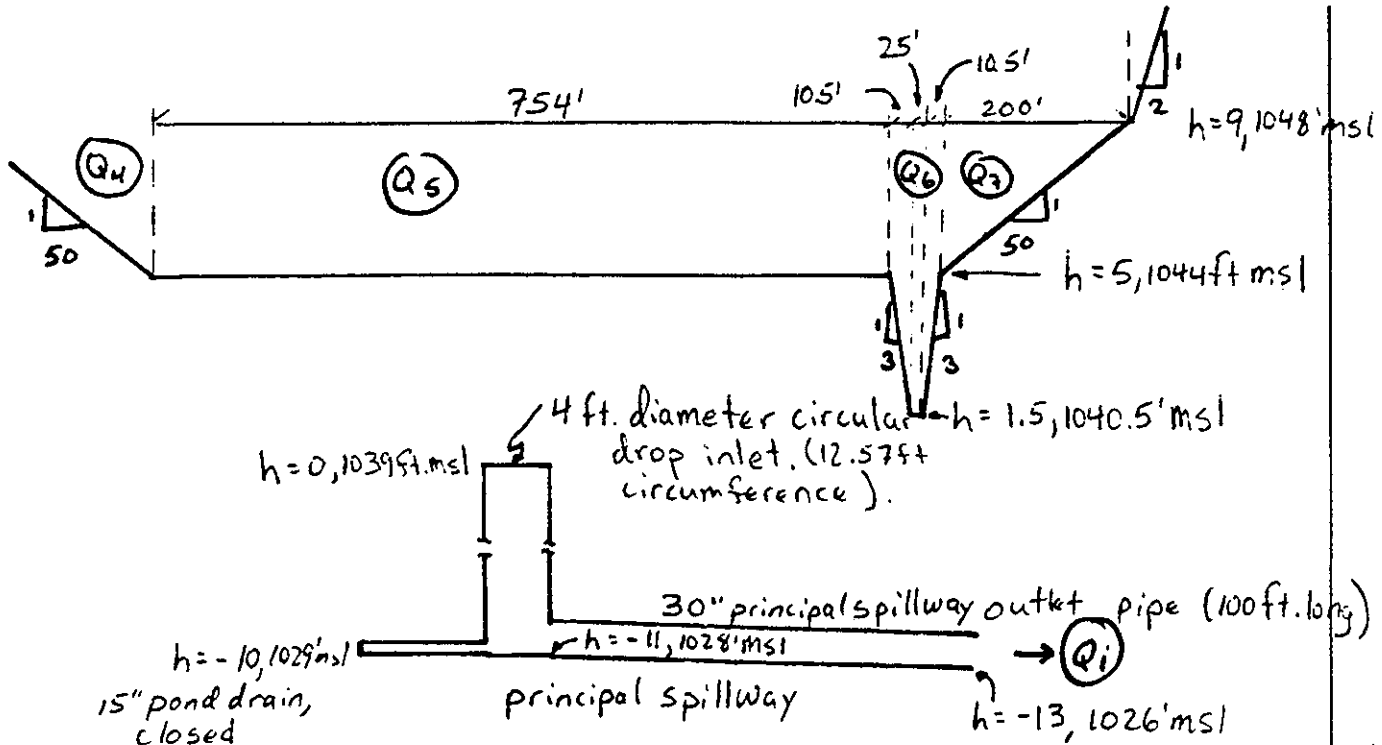
The elevation of Bog Brook Dam given below is based on field notes, dam plans, and USGS topo information.

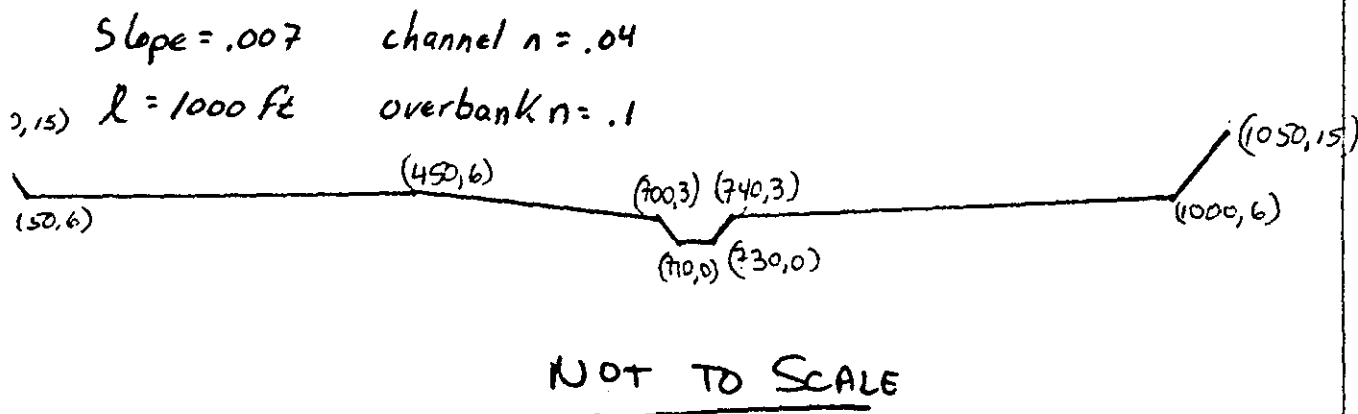
$Y_o$  is the difference between the water surface elevation behind the dam at failure and the tailwater elevation. This depends on the cross section downstream of the dam, which is shown below (established from field notes):

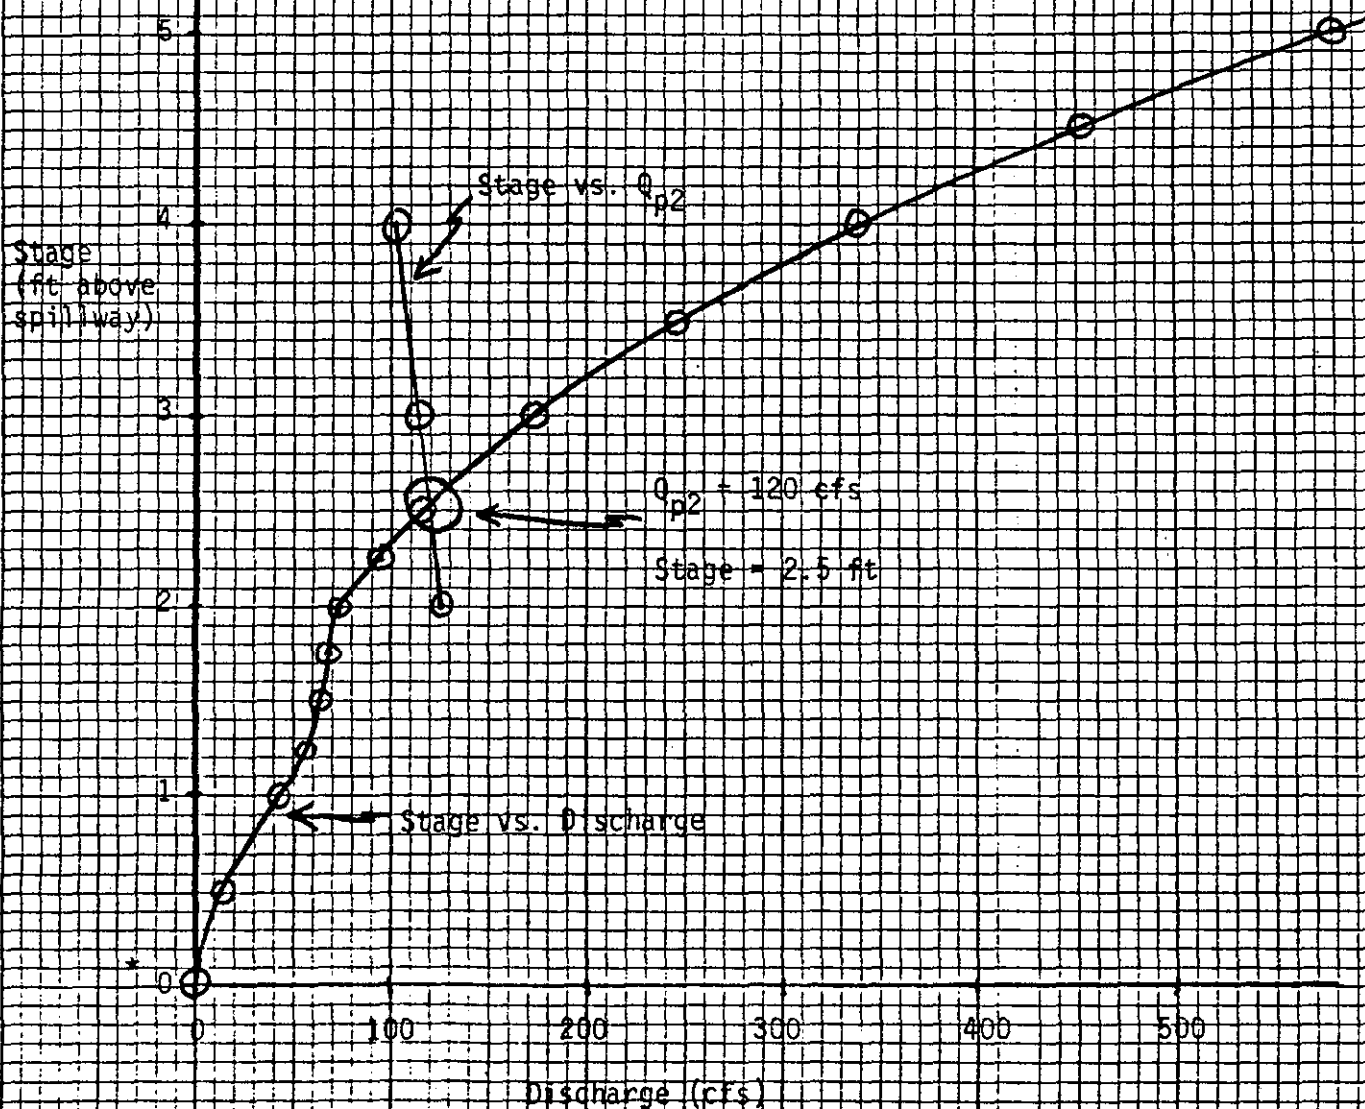
The peak test flood outflow is 120 cfs, with a peak stage of 1041.5 ft msl, 2.5 ft above the spillway crest, 1.0 ft above the emergency spillway crest, and 2.5 ft below the dam crest.

The peak test flood outflow is  $\frac{120}{580} = 20.7\%$  of the spillway capacity with the water surface at the dam crest.
